Finding Buried Treasure With Diamond Grinding

Source: CONCRETE CONSTRUCTION MAGAZINE
Publication date: May 15, 2009

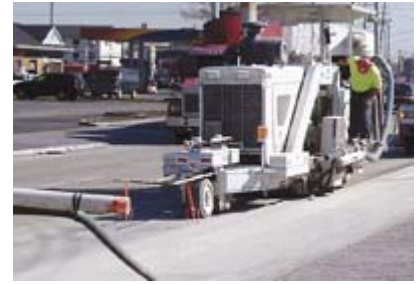
Once the overlay is removed, a variety of CPR options can be used.

The first step in implementing the buried treasure concept is to evaluate the pavement to ensure the underlying concrete pavement is worth investment. Once the overlay is removed, a variety of concrete pavement restoration (CPR) options can be used to manage the rate of pavement deterioration. As a nonoverlay option, it repairs areas of distress in concrete pavement without changing its grade. This procedure restores the pavement to a condition close to or better than original, and reduces the need for major repairs in the future. CPR techniques include slab stabilization, full and partial depth repair, dowel bar retrofit, diamond grinding, and joint resealing.
